| TITLE | : | Report on the fire properties of PVC-Ling ceiling system as determined by the SANS 10177 Part 5 and 10 test protocols |
| REQUESTED BY | : | PVC-Ling South Africa P O Box 70 Hennenman 9445 |
| CONTRACT No | : | FTC09-001 |
| DATE | : | 13 March 2009 |

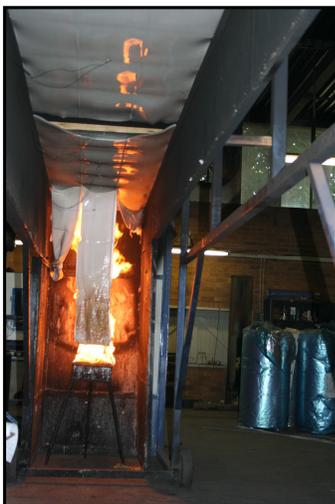
Figure 4.2.1: Front portion of ceiling dropped out after 5 minutes

At no stage during this evaluation was any ignition of ceiling installation observed. The material softened and systematically drooped and fell out of the hot zone without igniting. Figure 4.2.1 shows the installation after 5 minutes with the front portion of material having already drooped out of the hot zone.

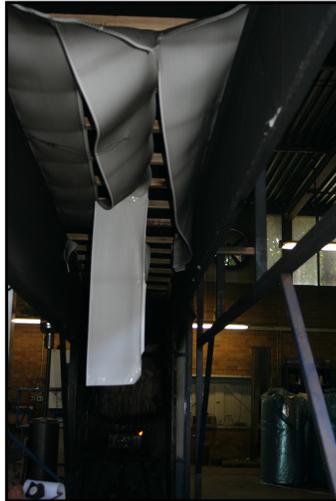
Figure 4.2.2: Test specimen subsequent to completion of the test

Figure 4.2.2 shows the installation subsequent to the completion of the test. Most of the installation had drooped out and softened but no ignition or flame propagation was observed at any time during the test.

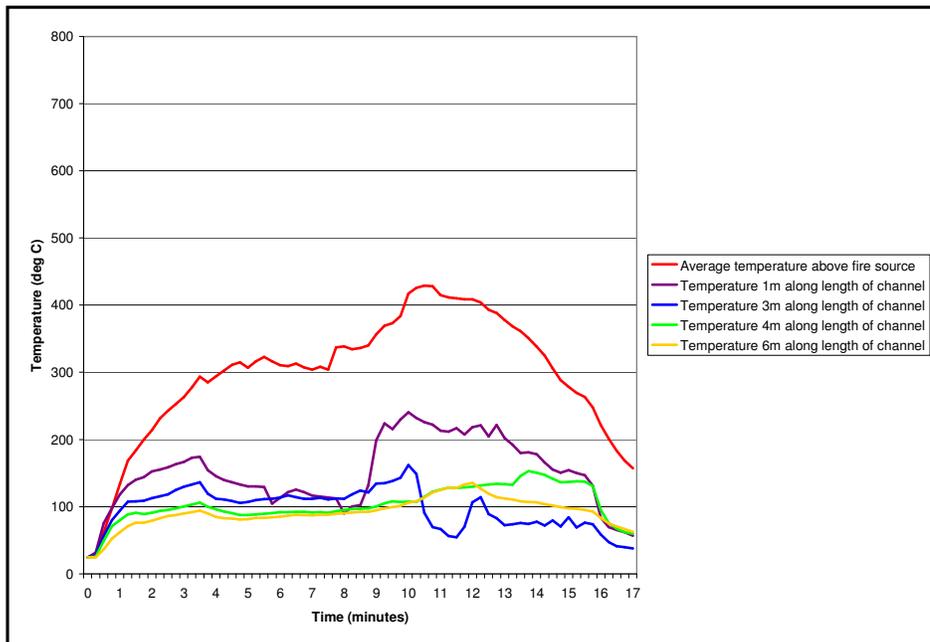
Figure 4.2.3: Temperatures recorded during the test on PVC-Ling ceiling system

The temperatures recorded in the furnace are depicted graphically in Figure 4.2.3. This plot confirms that no ignition had occurred as no secondary temperature peaks were noted at positions further along the length of the tunnel.

While the PVC-Ling ceiling material is classified as combustible based on the results of the SANS 10177 Part 5 test, the results from the SANS 10177 Part 10 test confirm that the material does not have a propensity to support flame spread. No ignition of the material and any resultant fire propagation were observed at any time during the test.
