# Fire Technology & Consulting Services

<b>TITLE</b>	:	Report on the fire properties of PVC-Ling ceiling system as determined by the SANS 10177 Part 5 and 10 test protocols
<b>REQUESTED BY</b>	:	PVC-Ling South Africa P O Box 70 Hennenman 9445
<b>CONTRACT No</b>	:	FTC09-001
<b>AUTHOR(S)</b>	:	K. van Dyk
<b>DATE</b>	:	13 March 2009

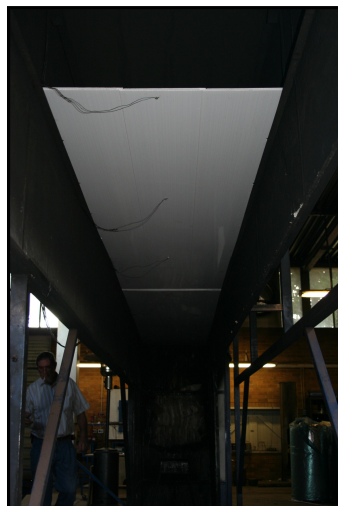
Temperatures were measured during the investigation with thermocouples located at various positions along the length of the installation. The test installation was exposed to the thermal output of three litres of n-hexane, which was placed in the fire source tray. Temperatures were continuously recorded and observations were noted of the behaviour of the material. The installation prior to the ignition of the fire source is shown in Figure 3.2.2.

**Figure 3.3.2: Test installation prior to ignition of fire source**

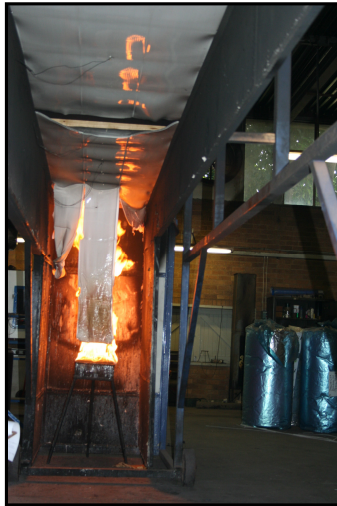
At no stage during this evaluation was any ignition of ceiling installation observed. The material softened and systematically drooped and fell out of the hot zone without igniting. Figure 4.2.1 shows the installation after 5 minutes with the front portion of material having already drooped out of the hot zone.

**Figure 4.2.1: Front portion of ceiling dropped out after 5 minutes**

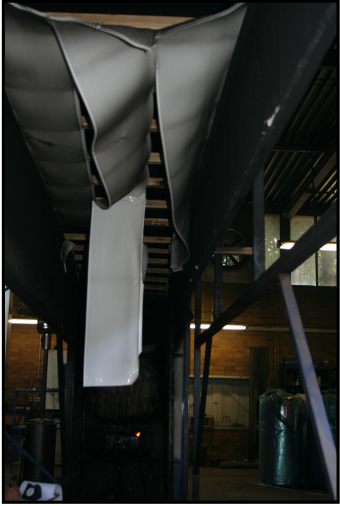
Figure 4.2.2 shows the installation subsequent to the completion of the test. Most of the installation had drooped out and softened but no ignition or flame propagation was observed at any time during the test.

**Figure 4.2.2: Test specimen subsequent to completion of the test**

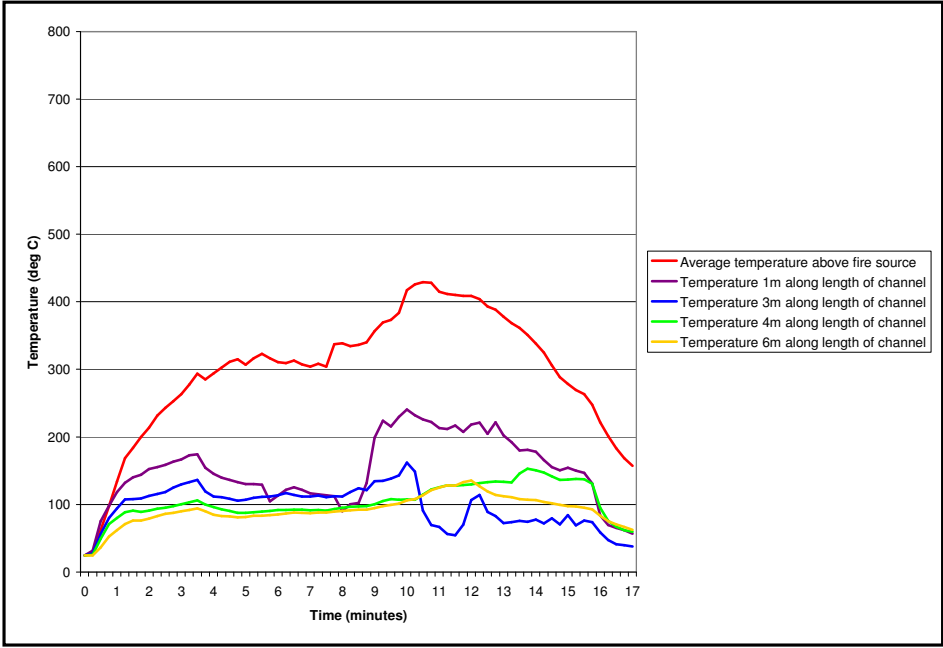
The temperatures recorded in the furnace are depicted graphically in Figure 4.2.3. This plot confirms that no ignition had occurred as no secondary temperature peaks were noted at positions further along the length of the tunnel.

**Figure 4.2.3: Temperatures recorded during the test on PVC-Ling ceiling system**

While the PVC-Ling ceiling material is classified as combustible based on the results of the SANS 10177 Part 5 test, the results from the SANS 10177 Part 10 test confirm that the material does not have a propensity to support flame spread. No ignition of the material and any resultant fire propagation were observed at any time during the test.
